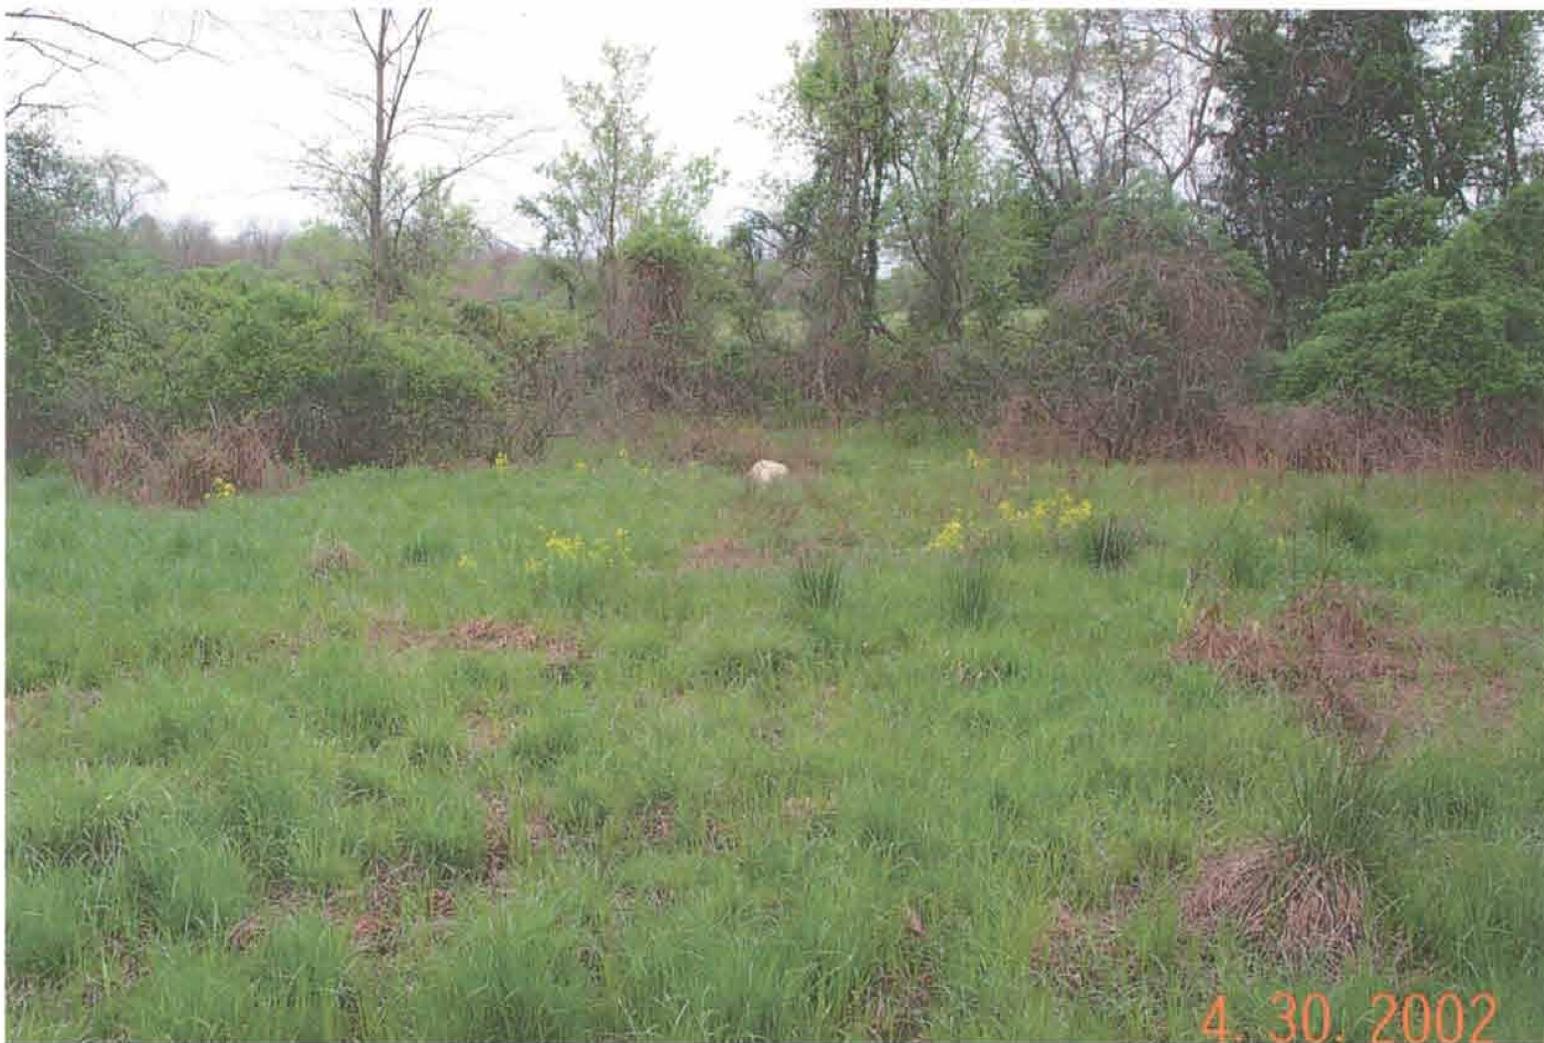
Figure 5. Small wet meadow between parking lot and stream.
